STATE OF NEW YORK
DEPARTMENT OF TRANSPORTATION

SOIL MECHANICS
BUREAU

PHYSICAL CONDITION SURVEY
AND
GEOTECHNICAL SUMMARY

GLENS FALLS FEEDER CANAL
GLENS FALLS TO HUDSON FALLS, N.Y.
MARCH 1988

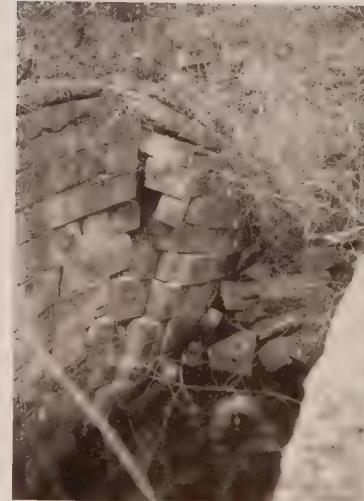
The canal is filled with debris and natural sediment. Sloughing and erosion of the slopes has occurred. Basically, the canal has transformed to the state of appearing to be a natural stream flow.

COLLAPSED WALL AT LOCK 2; sta. 40

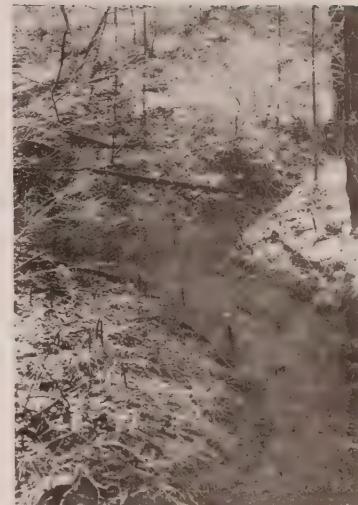
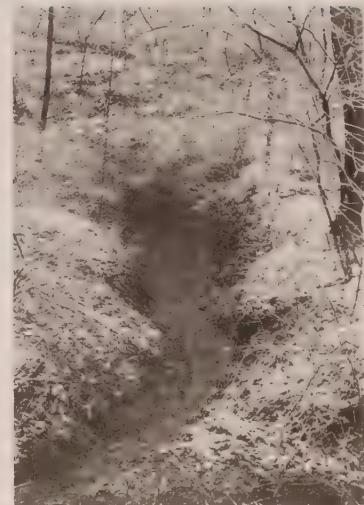
STREAMS DISSECTING THE OUTBOARD SLOPE
IN THE RESERVOIR AREA; sta. 135-136

Clean and shape channel. The debris should be removed and the inboard slope graded and dressed to ensure stability and prevent erosion. The critical area is the south wall which is within 15 to 20 feet from the top of the steep outboard slope in many places. The steep southern outboard slope which is dissected by the streams may be flattened and stone fill placed in areas where extreme erosion has progressed to the top of the slope. The hole in the floor at station 131+00 \pm should be filled with nearly impervious clay material. The trees and brush on the embankment should be cleared.

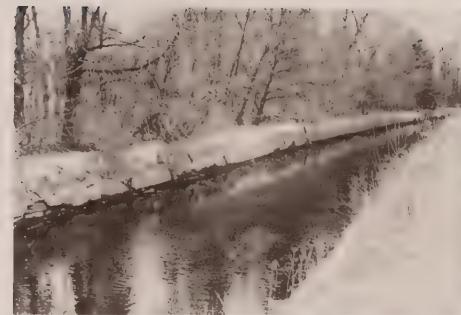
NORTH WALL IN DISREPAIR. NOTE WALL IN BACKGROUND IS IN GOOD CONDITION; sta. 167

Clean debris from canal. Repair holes in walls and clean sediment from floor and inspect for holes and cracks. Clear brush and trees on the embankment.

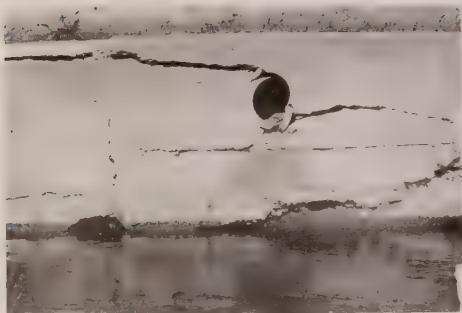
DETERIORATED NORTH WALL; sta. 205

The condition of the north wall and the possible development of leaks should be monitored throughout the section. If leakage is occurring, the north wall should be patched or treated by other means. Also, consideration must be given to the fact that the highway is very near these walls and that failure of these walls could be hazardous. Clear trees and brush from north wall.

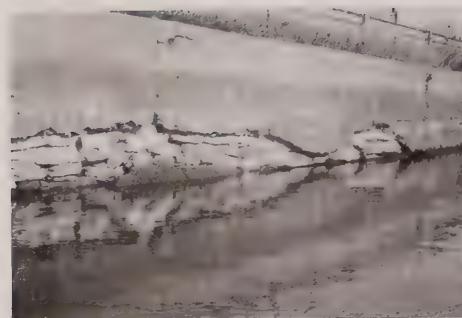
MISSING CONCRETE FACING REVEALING THE LAID UP STONE; sta. 206

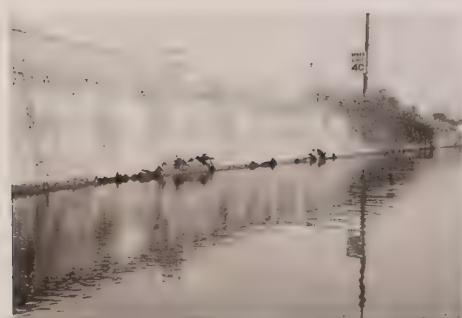
DETERIORATED NORTH WALL; sta 208

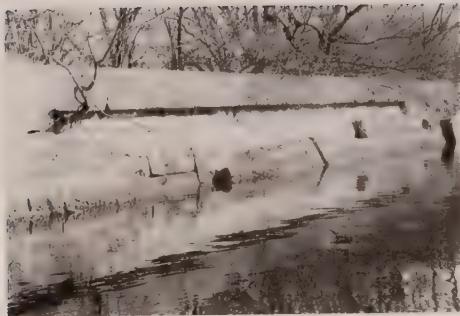
FALLEN CONCRETE FACING REVEALING THE
LAID UP STONE WALL; sta. 220

Recommendations			Recommendations		
First, the trees and brush should be cleared, especially where it is growing near and through the wall. Most likely the north wall will have to be repaired with a new facing to recover the recently exposed stone walls.			This is the site of a Contract D252276 (1988) let for the installation of a geomembrane liner used to seal the leaks. This contract consists of the installation of the liner, and repair of the wall facing. For typical liner section, see Appendix D.

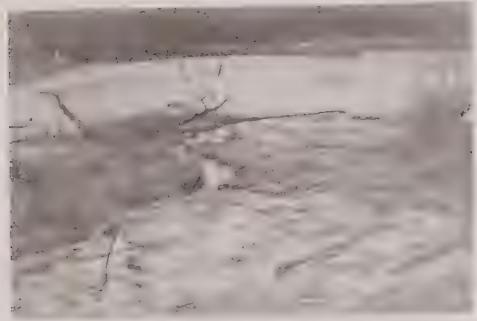
PONDING AREA FORMED BY LEAKING CANAL
WATER; sta. 221

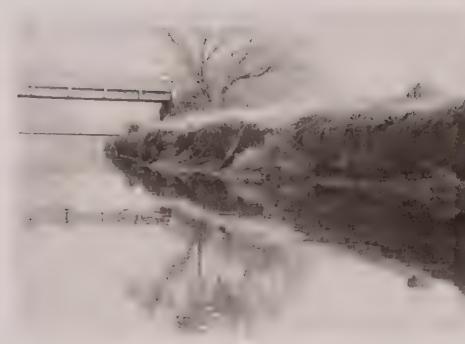
CLAY PATCH AT SOUTH WALL; sta. 228

The hole in the wall should be checked for leakage and patched if needed. The area of the clay patch should be monitored for leakage, and repairs made where needed. This may be a feasible site for the geomembrane liner, pending its performance from other sites. The trees and brush along the north embankment should be cleared, and the canal should be cleaned of all deleterious material.

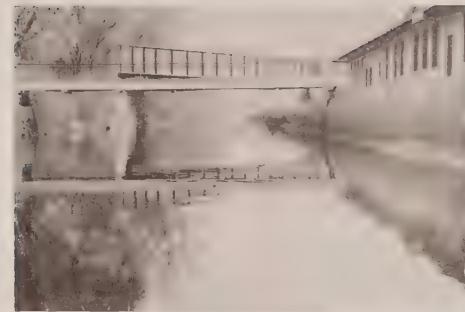
WALLS IN GOOD CONDITION AT IRON CLAD OFFICE; sta. 233

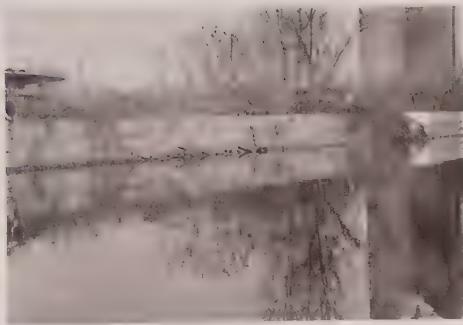
CRACKED AND SPALLED NORTH WALL; sta. 246

Monitor the clay patched area along the south wall for leaks. Clear trees from top of wall and clean debris from canal.

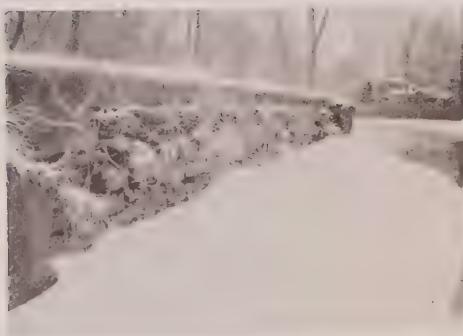
MISSING CONCRETE FACING AND TIPPED WALL;
sta. 247

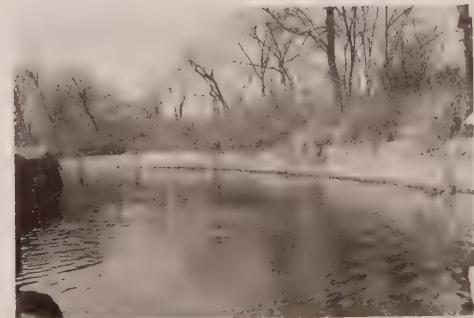
NORTH WALL OVERGROWN WITH TREES AND
BRUSH; sta. 257

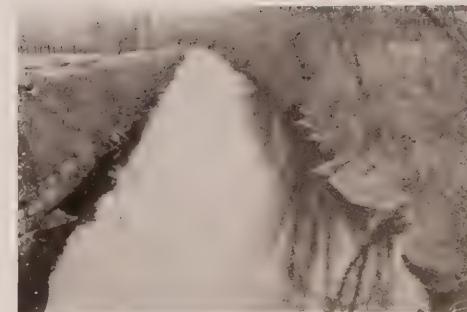
LAID UP STONE WALL COLLAPSING.
LOOKING UPSTREAM FROM STA. 299.

The walls should be repaired to prevent leakage and sloughing of the inboard slopes. Appropriate treatment should be chosen from the summary of recommended treatments. The trees and brush should be cleared from the slopes.

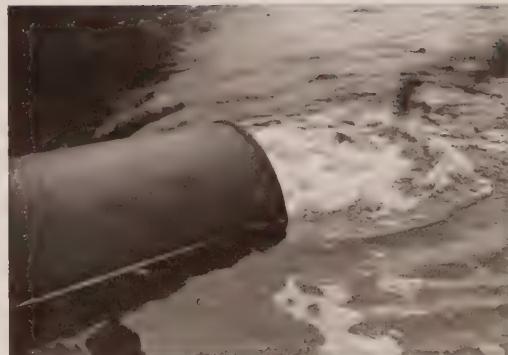
WASTE WEIR LEAKING INTO THE HUDSON RIVER; sta. 310+80

Repair waste weir. Clear trees and brush from wall areas. Check extent of sediment accumulation in canal bottom. Monitor walls and earth slopes for any movement or the development of leaks.

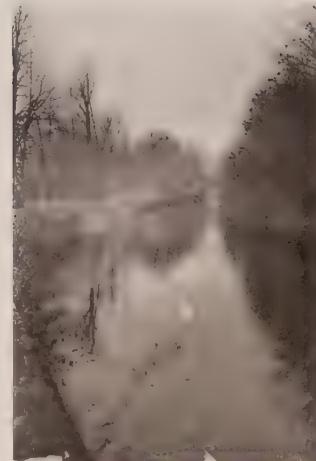
out" approximately 10 years ago. Presently, there is a 200 foot clay berm on the inboard side and stone filling on the outboard slope adjacent the Hudson River. This section of embankment is still leaking a large quantity of water.

VIEW OF CLAY BERM AT "BLOW OUT" SITE.
NOTE FEEDER DAM IN BACKGROUND. Sta. 380

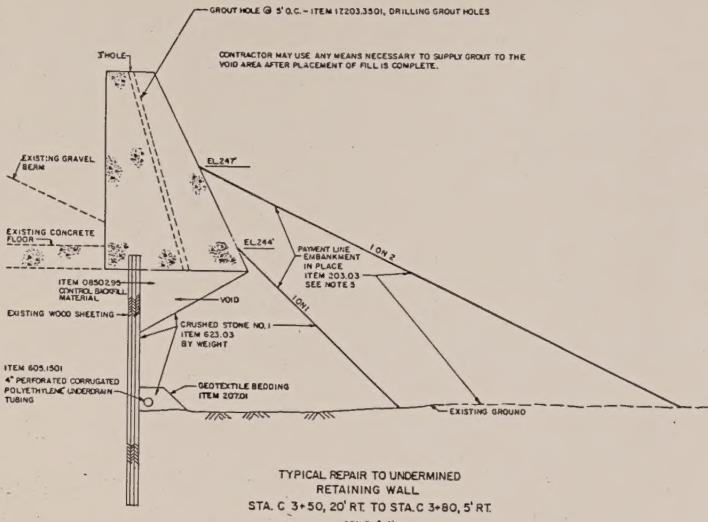
DETAIL A
MINOR CONCRETE REPAIR
D = 5" OR LESS

DETAIL B
MAJOR CONCRETE REPAIR
D = GREATER THAN 5"
